SAFETY ALERT

Helicopter Rotor Downwash Hazard

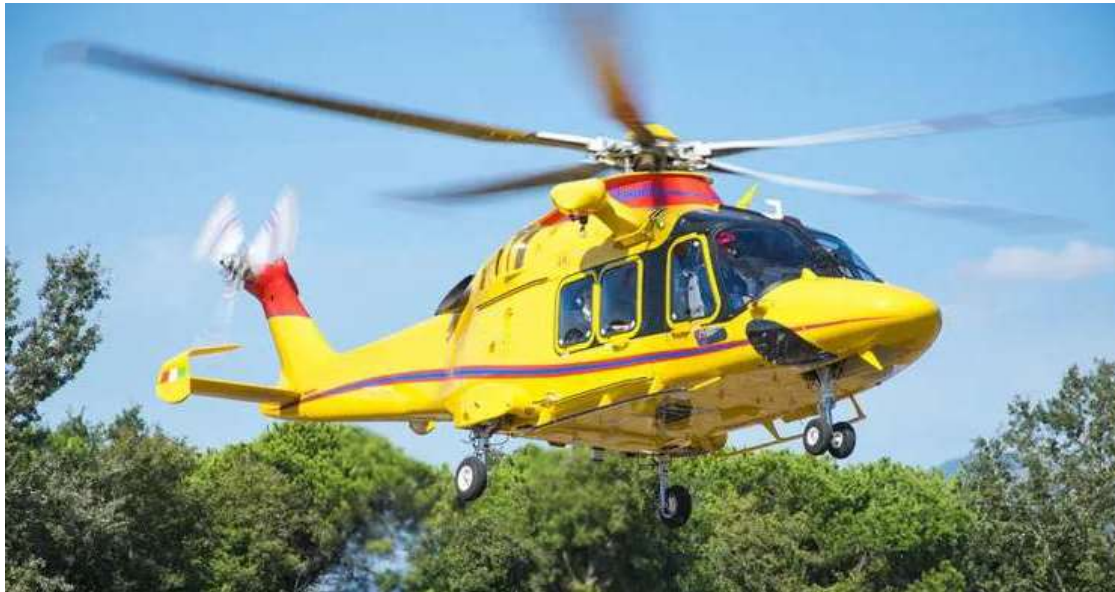
A recent incident on runway 03 occurred when a light aircraft experienced a balloon in the flare followed by a heavy landing. No damage was sustained to the aircraft.

It has been determined that the balloon in the landing flare was due to rotor wash turbulence from a medium sized helicopter holding at the intersection of taxiway Bravo and Sierra. The helicopter was holding in a hover and was well clear of the runway. Wind conditions on the day were light and variable. At the time of the incident the AWIB Metdata indicated a wind of 054 degrees Mag. at 4.5 knots. As the wind was coming from behind the helicopter, we believe the rotor wash was blown onto the runway which represents an estimated drifting distance of 70 metres.

Pilots of fixed wing aircraft need to be aware that the rotor downwash hazard from a 5-tonne helicopter is considerable and that wind direction and proximity are factors.

The helicopter operator is looking at ways to mitigate rotor downwash in similar situations.

If in doubt, go around.
